In Situ Remediation of Brine Impacted Soils and Groundwater using Hydraulic Fracturing

¹Gordon Bures, M.Eng., ²Ion Ratiu, M.Sc., and ³Craig Robertson

POSTER PAPER on:

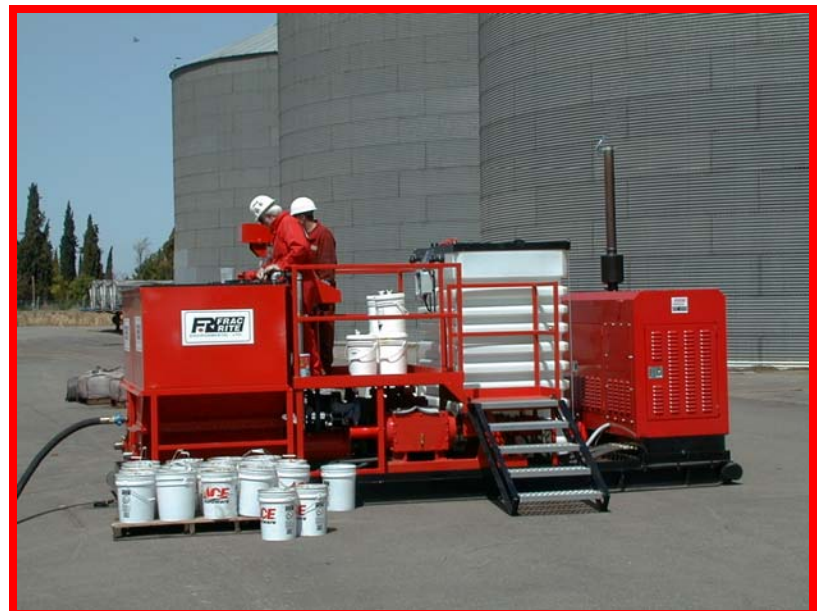
SOIL FRACTURING EQUIPMENT

The rationale for this approach is to create an *in situ* drainage network similar to that of tile drainage systems, by emplacing zeolites as discrete “drainage layers” via hydraulic fracturing. The zeolite fractures serve as both preferential groundwater flow paths while also providing *in situ* reduction in sodicity by ion exchange. Groundwater is collected from a central recovery well, treated, and re-injected into fractured wells to continue the leaching of salts from impacted soils. The advantage of this conceptual *in situ* approach would be to negate the need for disruptive excavation and topsoil reconstitution as practiced in conventional reclamation methods, and reduce costs. Furthermore, *in situ* treatment of saline impacts can be achieved without interference to ongoing crop planting and harvesting activities.

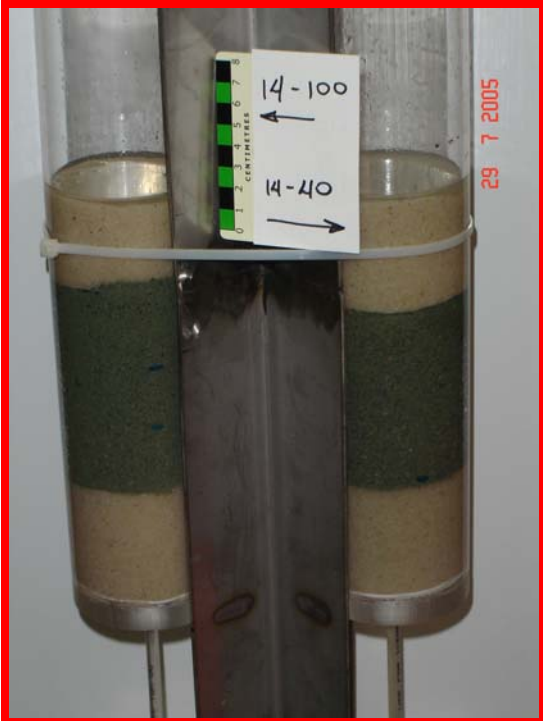
ZEOLITE COLUMN TESTING

Laboratory column testing was performed on different grades of zeolites to investigate their geotechnical and chemical performance with respect to the remediation of salt impacted soils and groundwater. The results of this testing determined that clinoptilolite, a calcium rich zeolite of high cation exchange potential with respect to sodium, was found to have the best properties for drainage and *in situ* reduction of sodicity.
